**STREAM TEAM REPORT FOR CITY OF YUKON
Mulvey Pond and Turtle Creek**

July 2005 Final Report

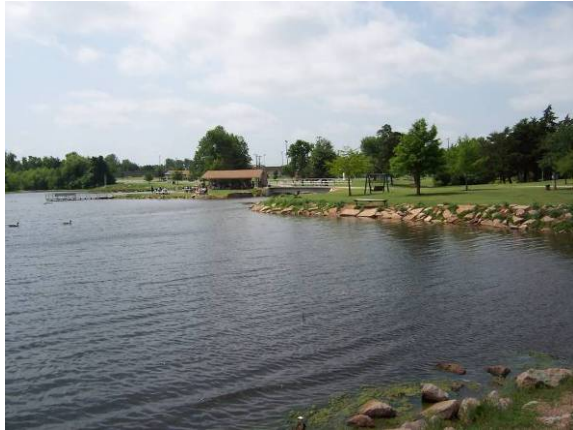
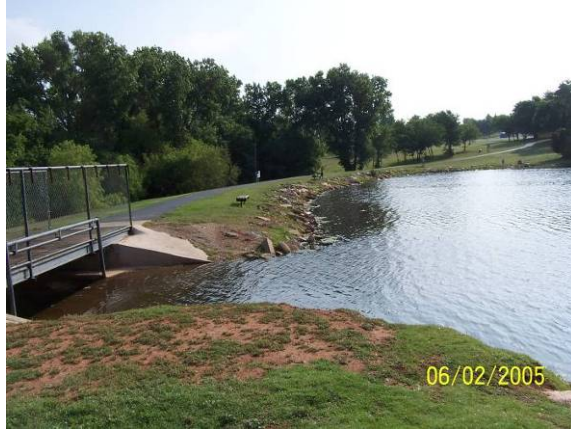
Figures 2 and 3: Concrete “Rip-Rap” on South and West Banks of Mulvey Pond

1. Mulvey Pond Rip-Rap: Figures 2 and 3 show the existing “rip-rap” on the south and west banks of the pond. This material is actually broken concrete pavement that has been in place for many years as evidenced by the well established vegetation growing between the material. The concrete, while not as attractive as true limestone or sandstone rocks and boulders typical to more formal rip-rap on slopes, is actually performing well to stabilize both the south and west banks of the pond. No significant pond bank erosion was observed. Removal of this material would require extensive use of heavy equipment and be very costly as would replacement with new stone.

Recommendations: Since the existing material is performing well, it is recommended that this be left in place. No changes to the material are recommended other than that trash and construction debris such as rebar should be removed to lower the risks to people using the area.

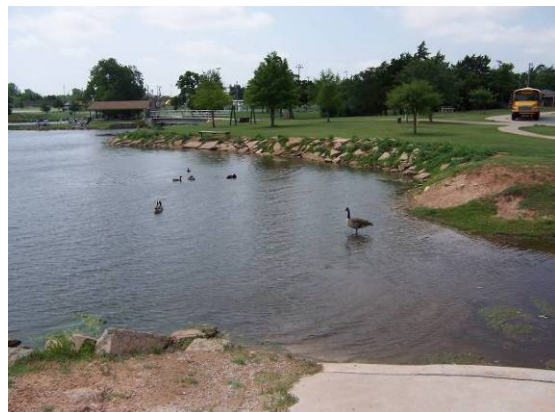
3. Water Quality in Mulvey Pond: Two sources of excessive nutrients were discussed before the meeting and at the site: the local duck and geese populations and upstream land uses that may contribute excess nutrients and sediment. While many Yukon citizens enjoy feeding and viewing the avian wildlife on the pond, other citizens are concerned that too many birds can contribute to water quality problems, especially nutrients and bacteria from fecal droppings. Anna Waggoner described the upstream land uses as being mostly rural with cattle and wheat production. At the end of this document, Chuck Potts, OWRB, provides a detailed evaluation of the water quality problems he has observed in past years in Mulvey Pond along with his recommendations. Bank stabilization with vegetation also aids water quality by reducing sediment loading and acting as a nutrient buffer from surface runoff. This will be

especially important along the east bank where vegetation buffers, trees and aquatic plants are recommended for establishment to control erosion. The pavilion and boardwalk into the pond on the west bank provide excellent opportunities for local schools to educate students on pond management and water quality. While only small amounts of floating and shoreline algae were evident on the day of inspection, Mulvey Pond is reported by Chuck Potts to have much greater problems with excess algae and nutrient over-enrichment at other times. Algae are plants that respond to fertilizer effects just as a lawn. Too many nutrients (too much fertilizer) results in excess algal growth. In ponds, this can turn water green, cause unsightly floating algal mats along the shoreline, release offensive odors and consume dissolved oxygen at night. While cleanup of algal mats in ponds is difficult work, mechanical harvesting of these mats is the best way to avoid nutrient recycling and otherwise introducing toxic chemicals for algal control.

Recommendations: Establishing a vegetative buffer and some trees on the east bank, along with aquatic emergent plants, will not only protect against erosion but provide enhanced water quality in the pond regarding sediment and nutrients. There are additional recommendations at the end of this document by Chuck Potts for stabilizing erosion at the pond inlet. Sediment loss and nutrients from upstream land uses will eventually end up in Mulvey Pond. Controlling pollutants at the source is much easier than cleaning the accumulations from the pond. Resources to help with land use nutrient management in watersheds are the NRCS, FWS, Oklahoma Conservation Commission (OCC) and OSU Extension Service (see contacts at the end of the document).

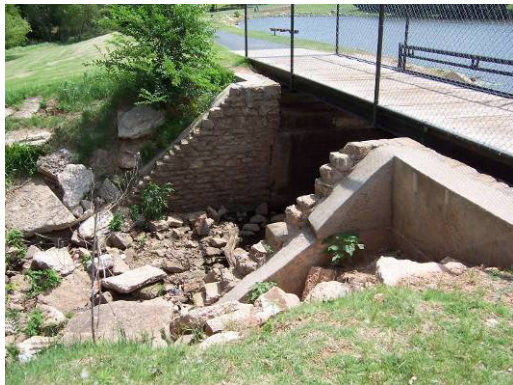
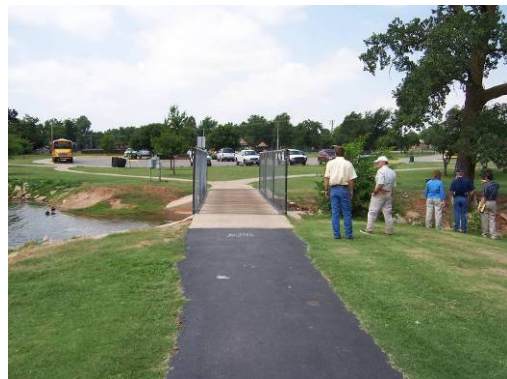
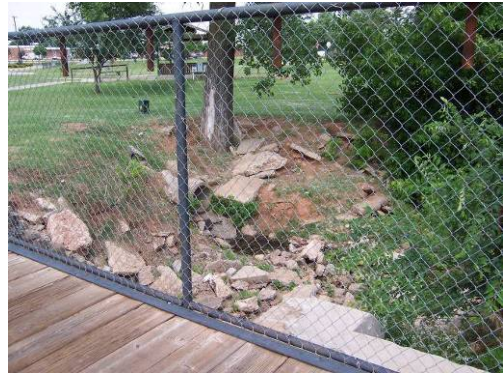
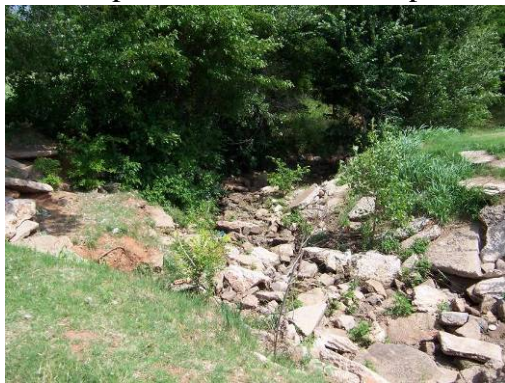
4. Mulvey Pond Outlet: There is considerable erosion at the outlet structure of the pond resulting from multiple sources. The flow over the pond weir is uncontrolled and can allow considerable volumes of water to fall quickly to the stream bed with great force.

In addition, the paved parking lot to the west of the pond apparently has mis-aligned drainage structures. Water from the parking lot enters via drop inlets, flows underground in concrete drain pipes and enters the creek at the pond outlet. The drop inlets along the curb of the parking lot are not at the lowest point so the water emerging into the creek via the pipe does not convey all of the water from the parking lot. Evidence of sediment residue and surface erosion between the parking lot and the creek suggests that there is

considerable flow from the undrained southeast side of the parking lot entering the creek. This surface flow has already started eroding around the new sidewalk and is apparently contributing to further erosion on the west stream bank between the foot bridge and the large cottonwood tree. The entire creek channel at the outlet structure is layered with old broken concrete paving that had been added as bank erosion but is now falling into the bottom of the creek with bare eroding banks exposed to further erosion. Not only is this unsightly, but if the erosion

continues, it could affect the structural integrity of the foot bridge base, the sidewalk on the west bank and the large cottonwood tree on the west bank. The east bank is more stable probably due to having less slope, more concrete rip-rap and no surface flows from the parking lot or drain pipe.

Recommendations: The parking lot drainage needs to be evaluated for ways to effectively channel runoff into the drainage system and minimize surface runoff across the sidewalk and down the stream's west bank. The concrete drain pipe emerging into the creek's west bank needs to have additional support and the west bank from which it protrudes stabilized to prevent further erosion. This may involve changing the slope of

the bank to 3:1 and adding toe-of-slope protection. As an alternative to a dry channel filled with rip-rap, the stream channel could be redefined by creating a small "stilling basin" using a permanent pool that would act to dissipate the water's energy from the drain pipe and from the pond's overflow weir. This would also create a more pleasant appearance. Much of the collapsed concrete paving needs to be removed from the creek bottom. A design engineer needs to provide plans and specifications for this project.

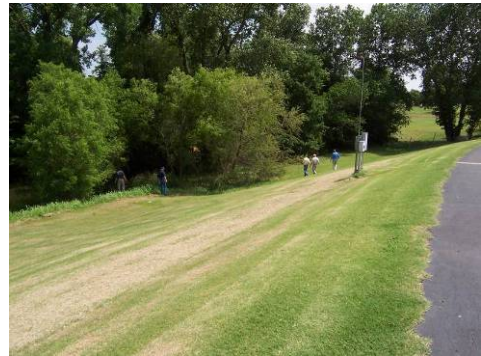
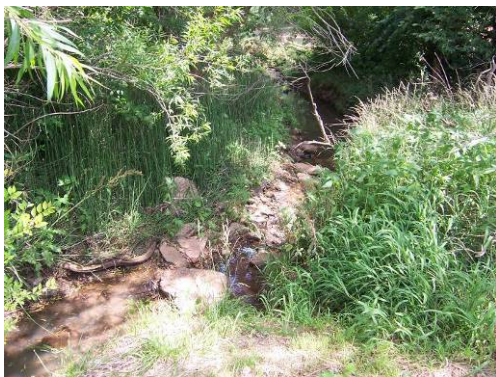
5. Turtle Creek Stream Bank Erosion: Much of the creek channel immediately downstream of the pond outlet is fairly stable with no significant erosion. There is a bermuda grass slope between the dam and the creek on the north face of the dam that is mowed by city crews. Past the dam face the stream turns north and enters a rich riparian woodland setting with a parallel trail of about 15 feet in width on the east bank. This riparian zone is approximately 10 - 20 feet wide on both banks and is apparently undisturbed (that is, not mowed or trimmed).

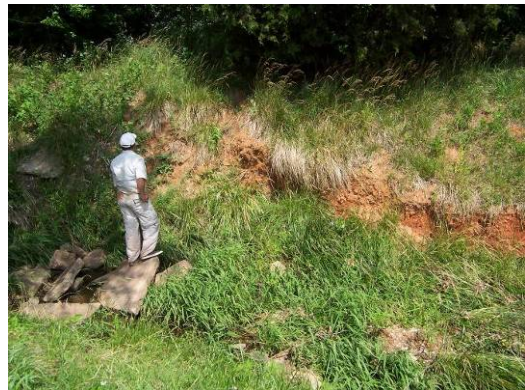
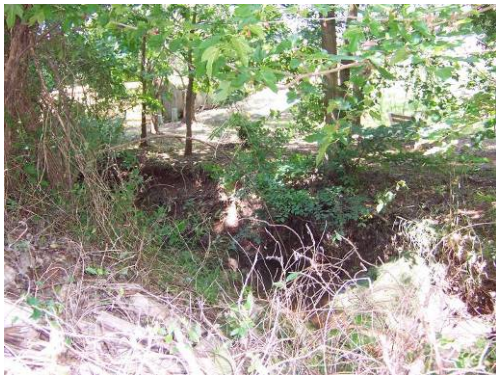
The north bank of Turtle Creek at the dam face is degraded in places. Portions of the bank have sloughed into the creek leaving sheared banks. This is likely due to increased velocity of water from the parking lot and pond, and perhaps realignment of the stream channel years ago during dam construction. The loss of natural channel meander length increases the channel slope which increases water velocity and shear stresses and thus erosional potential. Since bringing back stream meanders at the toe of the dam is not possible, other in-stream structures such as J-hooks or grade stabilization measures can be used to reduce stream velocity and deflect energy away from critical areas of the bank. These structures can create riffle-pool transitions that will protect the stream channel from erosion due to further meandering which can occur as the stream seeks to lengthen and decrease its erosional potential.

Recommendations: Erosion on the north bank by the dam is relatively minor, and energy dissipation structures should be considered to prevent further stream bank and channel erosion. Portions of the north bank may need to be re-sloped to provide greater stability. Consulting with the FWS, NRCS, OSU Extension Service and OCC staff may provide sufficient information to do this with local city equipment and resources, and these organizations may be able to identify some funds to help offset part of the cost. The more significant erosion further downstream may require formal engineering design to address erosion caused by excess runoff from street drains between homes, the tributary and the three swales from the park to the east that act to conduct surface runoff from the park to the creek. The same agencies listed above can

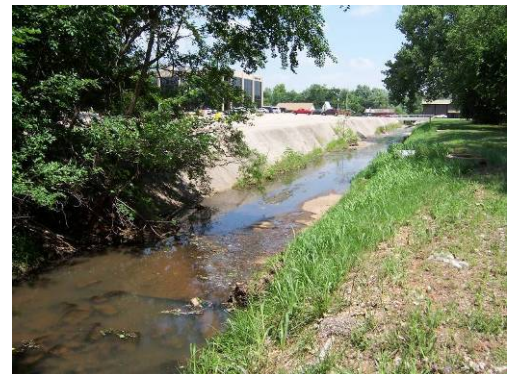
Further downstream, additional points of entry for surface flow are evident. These include several sloped grassy paths or swales from the park uphill to the east (see Figure 1 aerial), and a tributary between homes and a concrete surface drain between two homes apparently draining the street in front of the homes. These new water sources cause additional flow in Turtle Creek. As a result, the creek channel widens and deepens, and erosion is more pronounced. This continues to the point where the creek channel has been lined with concrete.

The transition between natural channel and concrete channel is eroding slightly and will need to be stabilized to prevent eventual undermining of the concrete channel. This point represents the farthest downstream location of the field inspection by the Stream Team staff.

provide information on potential resources and level of effort needed to restore the creek channel. The City should integrate the design to control surface runoff from the park to the creek on the east bank into the plans for improving the trail and nature walk.

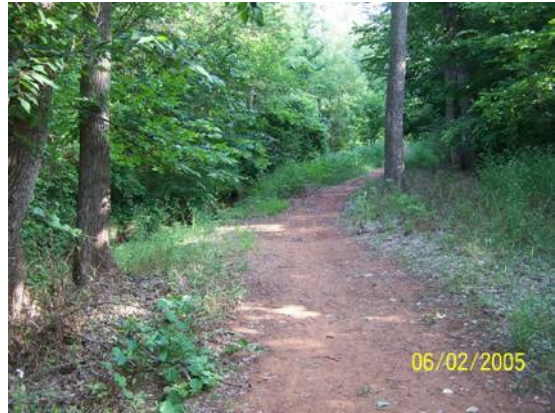
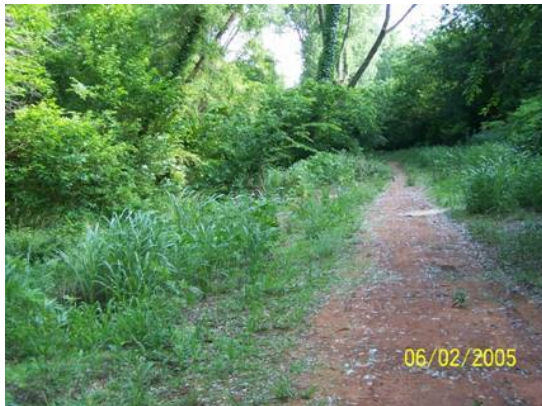
6. Improving the Trail and Options for a Nature Walk: The existing dirt trail extends from the dam northward to the concrete lined channel. Initially, it was thought that the trail could be extended along the west bank of the creek with an access bridge by the concrete channel. However, there are too many homes that now have lawns, fences and yard structures (planters, swing sets, flower beds, etc.) that are too close to the creek to allow a trail. However, the existing trail on the east bank has a fairly stable and well-compacted dirt bed, and the tree canopy and understory brush are far enough from the trail to allow at least a 10 to 15 foot wide path. Several places will require stabilization, especially by the grassy paths or swales that channel surface runoff from the park on the east upslope bank. Any hardening of the trail (e.g. gravel, screenings, asphalt, etc.) will need to account for this surface flow from the park. It was not clear what type of drainage systems exist at these

locations as the east side of the trail dropped off in many places to low areas with thick brush. Some concrete pipes were seen, but it is not known how effective they are for conveying the park's drainage under the trail to the creek.

Recommendations: The existing trail has great potential for urban recreational use and can also incorporate wildlife habitat amenities including use as an arboretum and education experience for local schools. Decisions concerning the ultimate use of the trail rests with the City's planning process, therefore City officials need to begin long range planning for the trail.
